Recreation Field Cowling

Preliminary Drainage Investigation

Final Report

February 2018

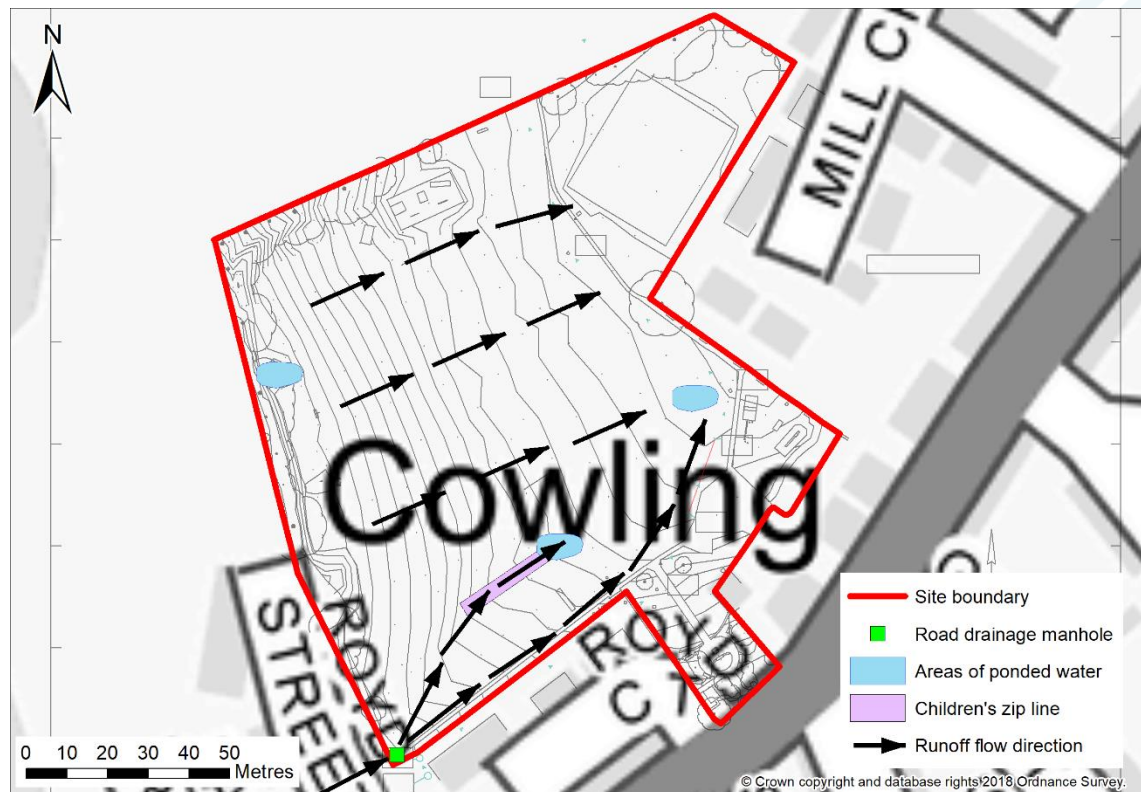
Figure 1 - Site Runoff and Drainage Issues

With reference to Figure 1, following periods of heavy rainfall general waterlogging across the field and ponding of water in localised areas such as the children's play area restricts access to, and enjoyment of, recreation equipment and the field in general.

Whilst there are specific areas of ponding it was apparent following heavy rainfall during the site inspection in November 2017 that all areas of the field generally experience waterlogging which is most likely caused by poor soil drainage.

Whilst gradients across the field are relatively steep, localised depressions occur which are prone to standing water. It is reported that this ponding of water can occur after rainfall events in any season. This ponding is most evident beneath the children's zip wire and on the footpath adjacent to the eastern boundary. In this area it is reported that overland flow results in water ponding against the boundary wall which may potentially impact the adjacent residential area of Mill Close). Further ponding was evident in the narrow plateau at the top of the field in the area of the bench.

It is also reported that runoff from Royd Street to the west contributes to the localised flooding, issues within the recreation field. Royd Street is understood to be an unadopted road with little or no surface water drainage. For unconfirmed reasons it is understood that Yorkshire Water previously blocked off a drainage manhole which collected water discharging from a concrete channel adjacent running adjacent to the footpath leading from Royd Street. Whilst these inflows contribute to the recreation field drainage issues it is unlikely to be the root cause of waterlogging due to the limited flow path. However, it contributes to the volume of water that needs to be drained in the vicinity of the children's play area / rope slide and may cause issues in terms of standing water for users of the southern footpath, especially during winter months.

In summary, it appears that drainage problems are primarily caused by poor soil drainage characteristics across the entire recreation field. In localised areas, this general waterlogging is exacerbated by the occurrence of localised ground depressions where runoff naturally collects after rainfall events and also the overflow from the Royd Street drainage channel.

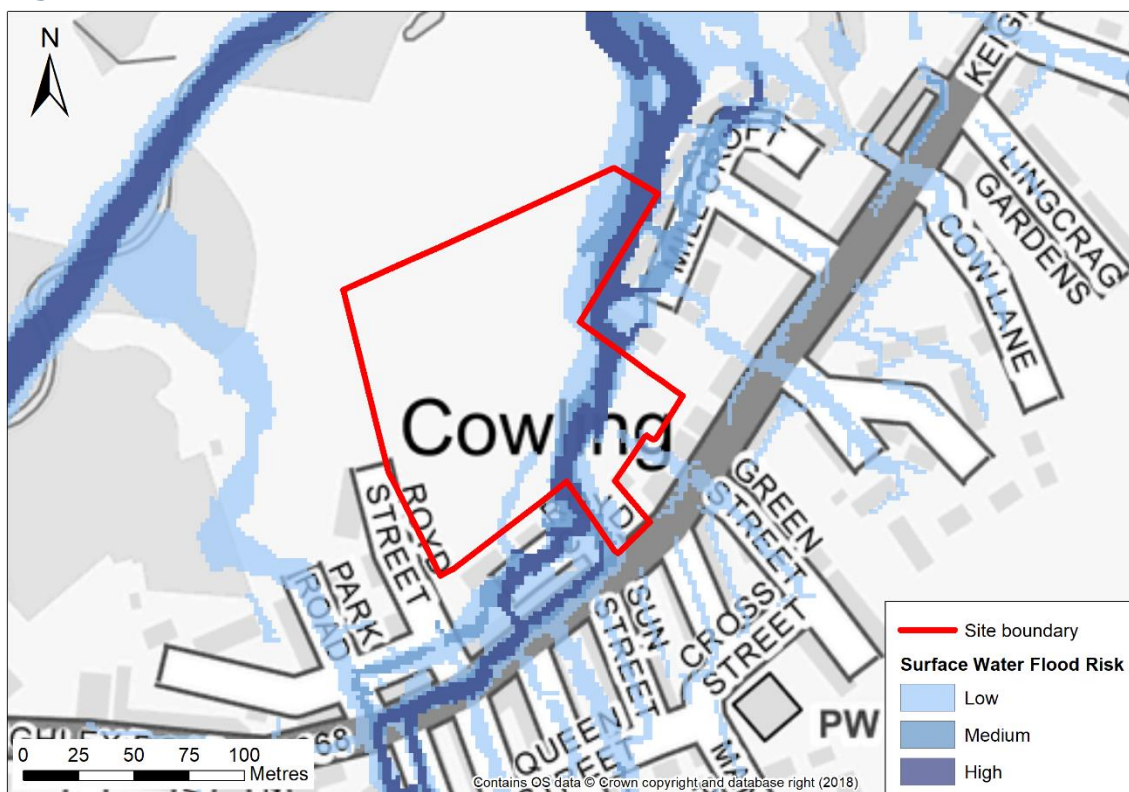
Figure 2 - Surface Water Flood Risk

With reference to the Environment Agency National Surface Water Flood Mapping (Figure 2) it is evident that in addition to the general land drainage issues, there is a potential flood risk to the recreation field as a consequence of overland surface water flow from the upstream Gibb Syke catchment. Whilst the surface water outlines do not appear to have incorporated the existing Gibb Syke culvert, mapping provides an indication of the likely flow routes and extent of flood risk should the culvert become blocked. This indicates a flow route and flood risk to the north-eastern area of the recreation field under each of the three mapped flood events (1 in 30 (High Risk) 1 in 100 (Medium Risk) and 1 in 1000 (High Risk) Return Period flood events). In these scenarios flow depths across the recreation field are indicated to be generally shallow (less than 300mm) although given the topography the flow velocities are indicated to be in excess of 0.25m/s, meaning that the flood hazard rating would be high.

However, it is noted that with the exception of localised flooding in Woodland Street no further records of historic flooding have been provided and this indicates that the culvert is currently conveying flow beneath Cowling. Residual flood risk during extreme events combined with culvert blockage is currently undetermined. Whilst outside the scope of this assessment which is limited to localised drainage issues within the recreation field, given the potential flood risk associated with upstream culvert blockage the Parish Council may wish to liaise with the Lead Local Flood Authority in relation to the condition and maintenance arrangements for culvert upstream of their land.

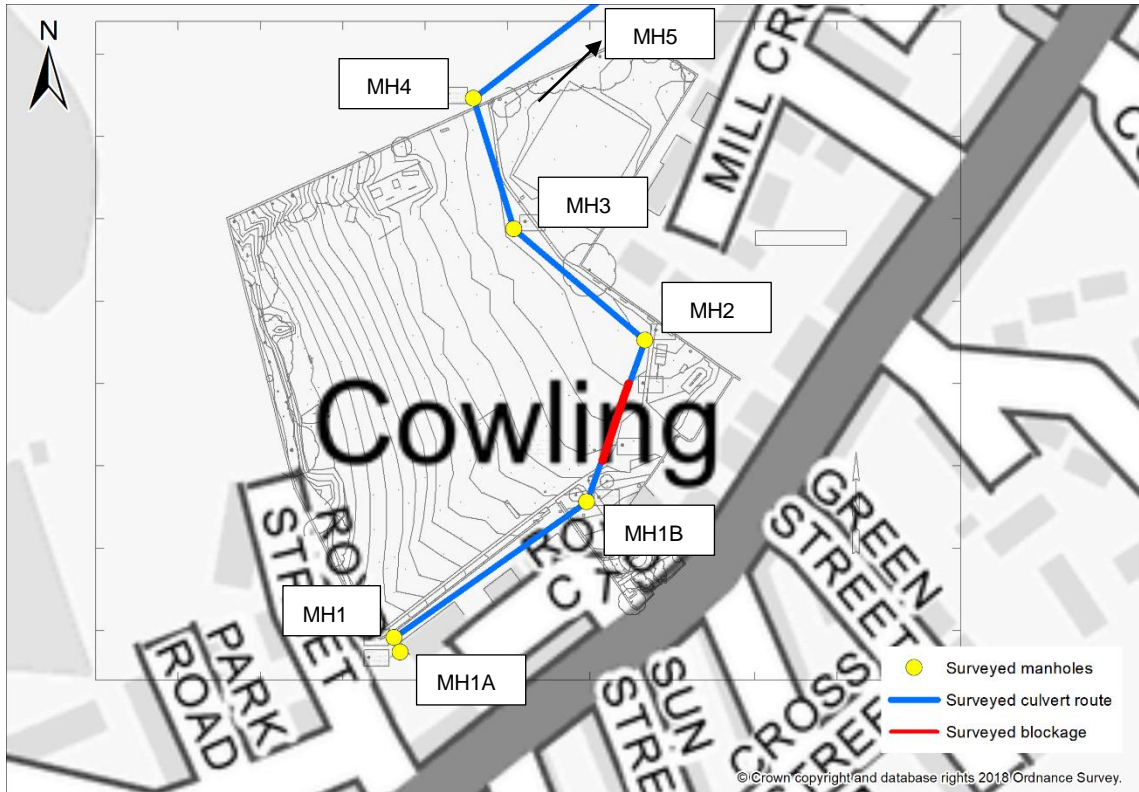
Figure 3 - Plan of Surveyed Culvert Alignment in Recreation Field and Blockage

The survey confirms the route of the culvert through the site, which is indicated Figure 3 overleaf with accurate survey of the manholes in the Survey Report drawings. The culvert, which follows the southern boundary of the site, doglegs along the eastern boundary and exits the recreation ground to the north. The culvert at this point makes another dogleg east, following the boundary of the Mill Croft residential area. The culvert discharges to open watercourse downstream of Mill Croft (shown in Figure 4). The culvert flows through a series of 8 manholes beneath the recreation ground and downstream area to where it joins a masonry outfall of unconfirmed dimensions. CCTV survey of the outfall was not possible due to a vertical drop in alignment at a buried chamber, however it appears that the culvert joins perpendicular to the masonry structure. This further substantiates the view that the current alignment was modified to accommodate the housing.

The inspected sections of concrete culvert were found to structurally be in a fair condition beneath the recreation ground. However, the culvert between MH1B and MH2 was significantly blocked with stone resulting in an inability to fully inspect this section. The settled stone deposits have reduced the cross sectional area by up to 50% over the inspected sections which would significantly reduce the culverts flow capacity as shown on the Photographs in Appendix B. This length is indicated on Figure 3. An intruding flowing pipe connection was seen to enter the culvert 2.2m upstream of MH2.

Using an assumed conservative pipe roughness equating to between a fair and poor condition culvert ($K_s = 0.3 \text{ mm}$) it was estimated that the culvert capacity increases downstream from Royd Street to the northern extent of the recreation ground, from $3.2 \text{ m}^3/\text{s}$ to $4.0 \text{ m}^3/\text{s}$. Downstream of the recreation ground the culvert pipe-full capacity increases to an estimated $6.9 \text{ m}^3/\text{s}$. This does not take into account the blockage between MH 1B and 2 which would significantly reduce culvert capacity.

Irrespective of the options developed or ultimately implemented to address the drainage issues local to the recreation field, it is recommended that the blockages identified within the culvert by the recent CCTV investigations are removed as a short term priority.

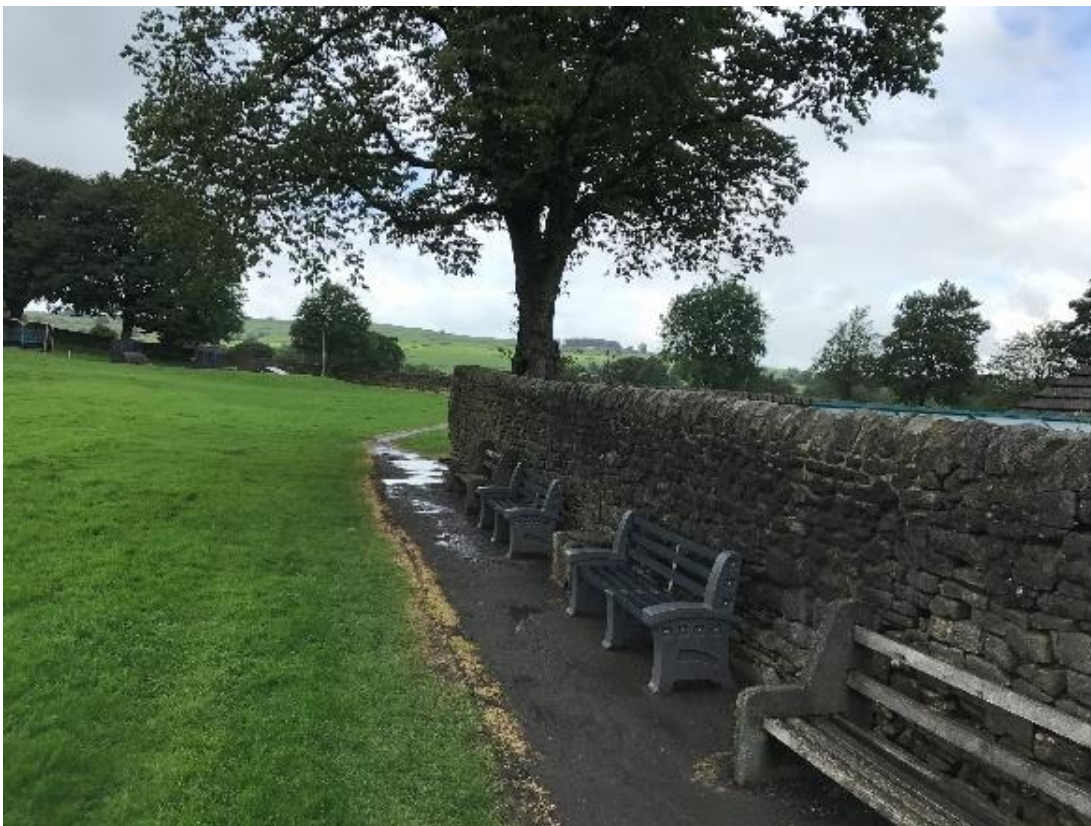
Photograph 6 – Standing water on the path leading to the tennis courts

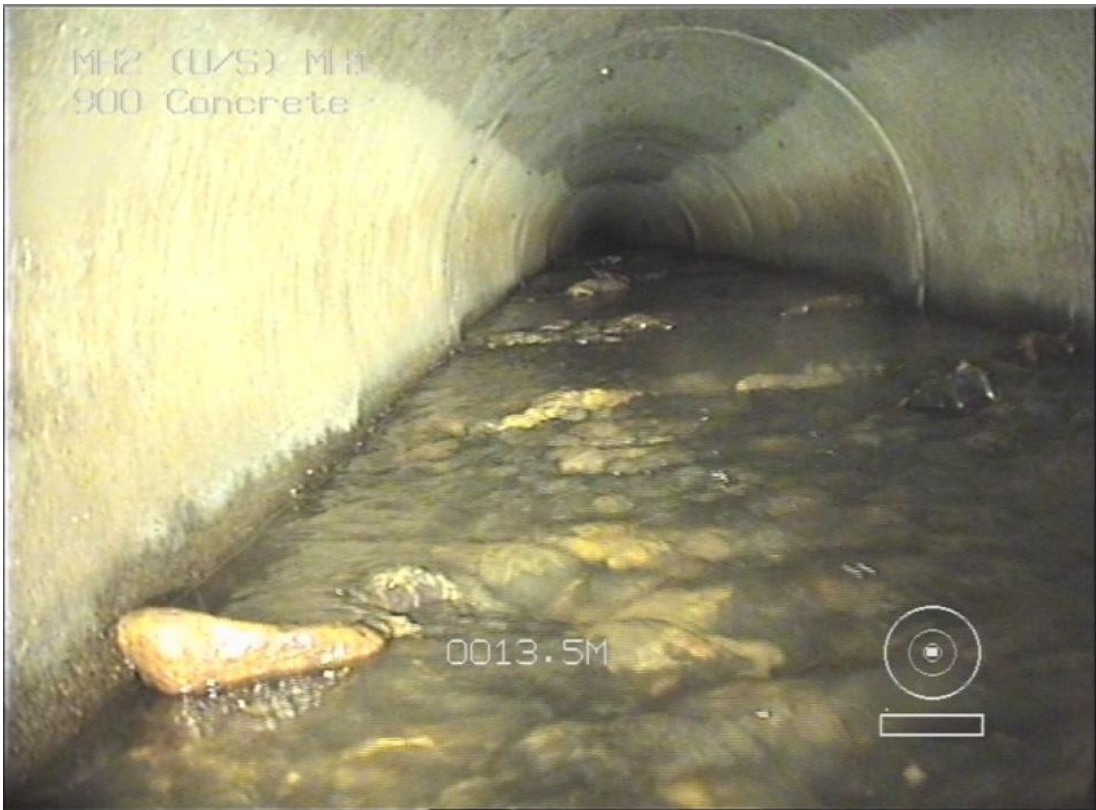
Photograph 7 – CCTV image of the culvert blockage

Notably in relation to the culvert blockage there are responsibilities to let water flow naturally and remove blockages that could cause flooding.

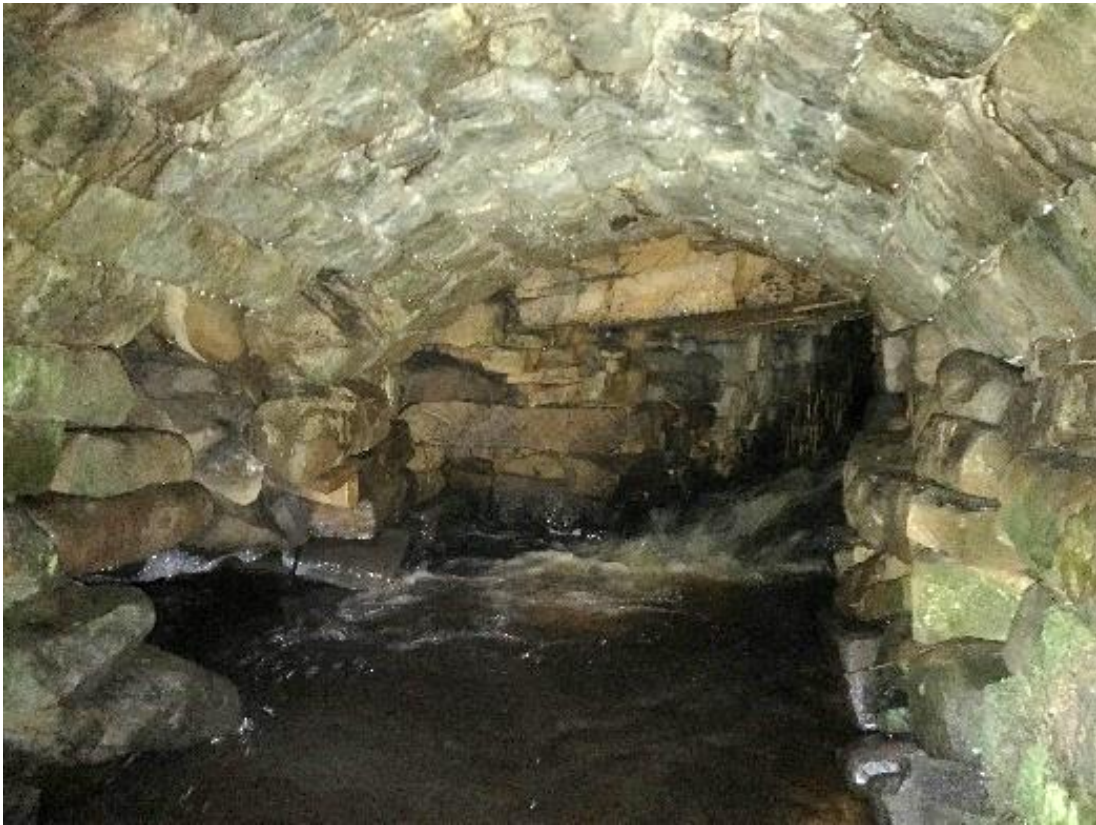
a full inspection of the outfall was not possible, from visual inspection there was some evidence of washout of material from the wall of the masonry culvert (see Photograph 8 in Appendix B).

Although the Council is not riparian owner of the final reach of the culvert to its outfall, we draw attention to the poor condition of the masonry brick arch (as shown in Appendix B photograph 8). If this section of the culvert were to collapse, this could result in significant conveyance issues upstream on the culvert, resulting in the surcharging of the culvert through the site, and the inability of any future site drainage to discharge to the culvert.

Photograph 8 – Photograph of the brick masonry arch at the culvert exit
