## CCTV SURVEY INSPECTION REPORT

<b>Client:</b>	JBA Consulting
<b>Location:</b>	Gibb Syke Culvert, Cowling
<b>Date:</b>	23 <sup>rd</sup> January 2018

Project Name: 2017s6518 Gibb Syke culver	Project number: 2017s6518	Date: 16/11/2017	Contact: David Barton	
---	------------------------------	---------------------	--------------------------	--

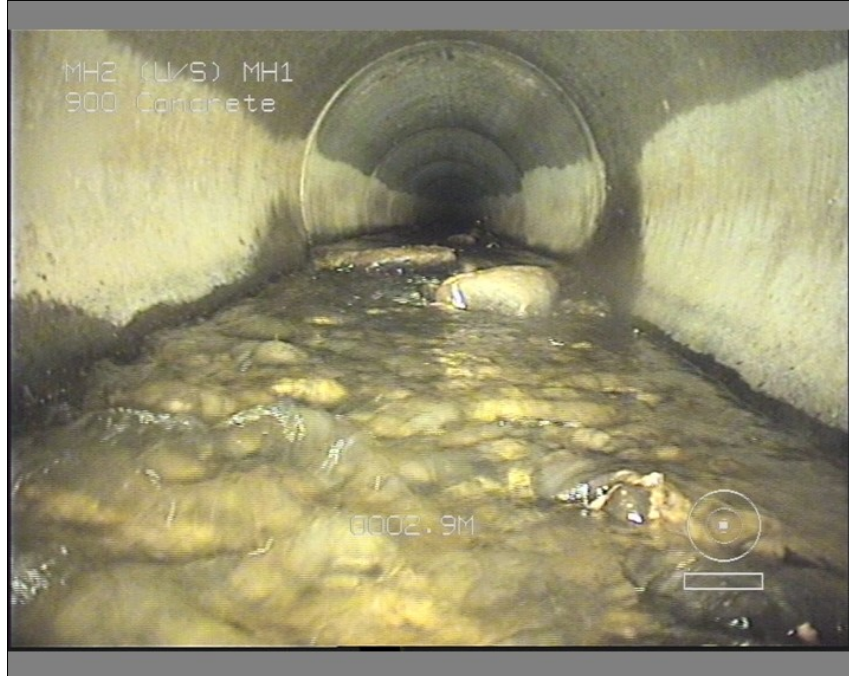
2.20	CXI	Connection intruding, at 10 o'clock, diameter 300mm, intrusion 20%		3
	2.90	DER	Settled deposits, coarse, 30% cross-sectional area loss	1_1_5_A.JPG	4

Photo: 1\_1\_5\_A.JPG  
 2.9m, Settled deposits, coarse, 30% cross-sectional area loss

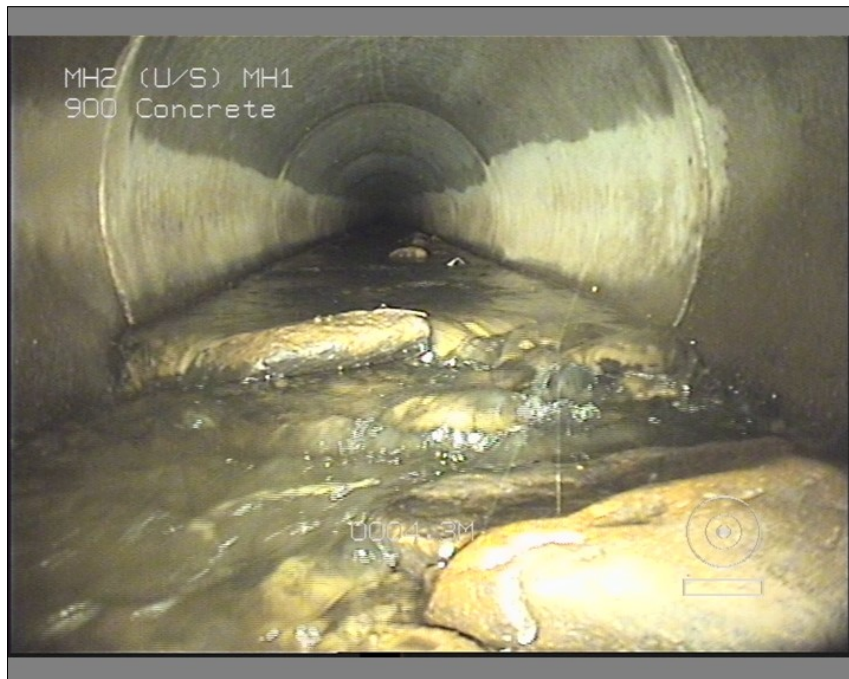
4.30	OBB	Other obstacles, brick or masonry in invert, from 5 to 8 o'clock, 30% cross-sectional area loss	1_1_6_A.JPG	5
	7.20	S01 DER	Settled deposits, coarse, 30% cross-sectional area loss, Start	1_1_7_A.JPG	4

Photo: 1\_1\_6\_A.JPG  
 4.3m, Other obstacles, brick or masonry in invert, from 5 to 8 o'clock, 30% cross-sectional area loss

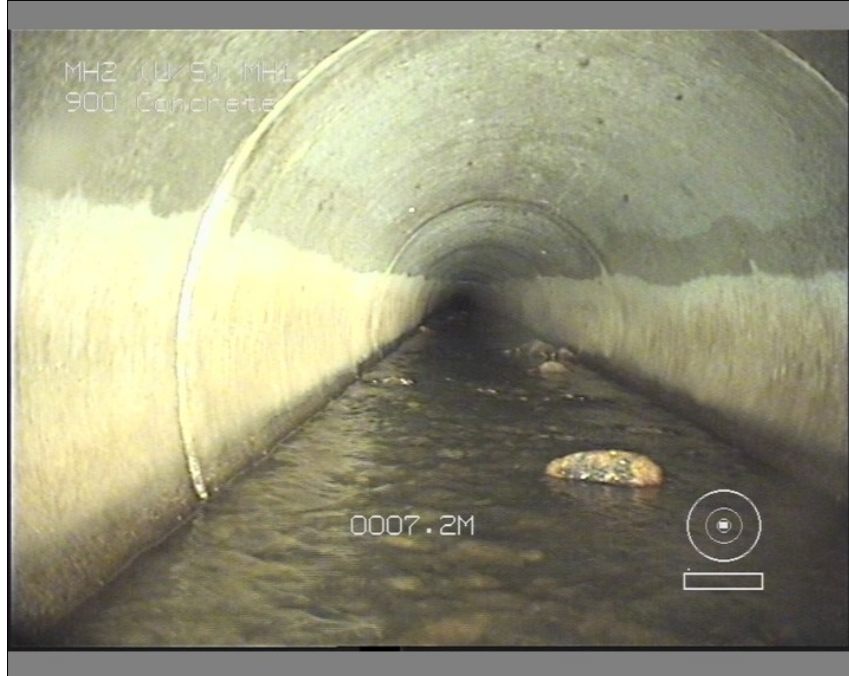
Photo: 1\_1\_7\_A.JPG  
 7.2m, Settled deposits, coarse, 30% cross-sectional area loss, Start

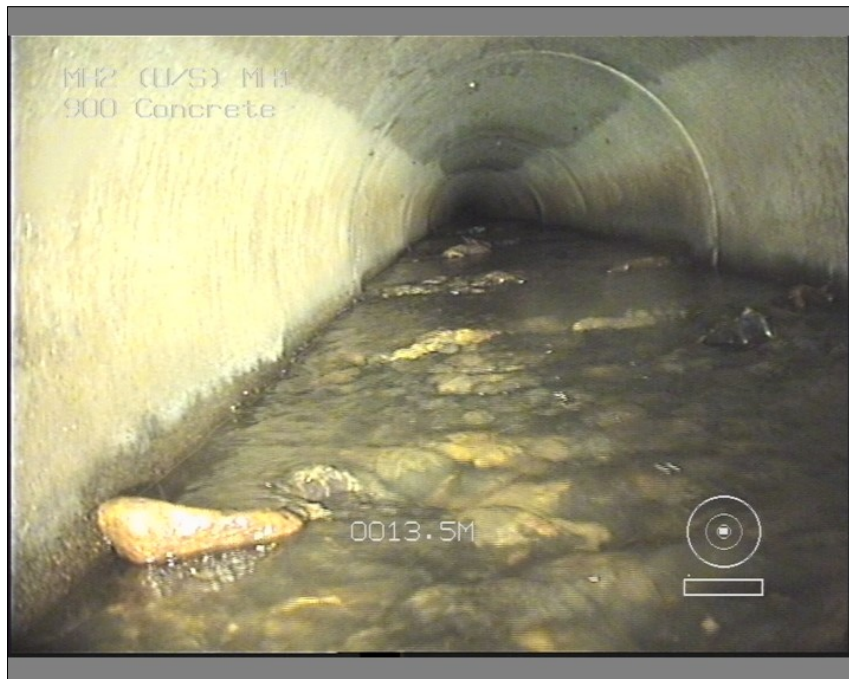
7.20	WL	Water level, 30% of the vertical dimension		0
	13.50	F01 DER	Settled deposits, coarse, 30% cross-sectional area loss, End		4
	13.50	S02 DER	Settled deposits, coarse, 40% cross-sectional area loss, Start	1_1_10_A.JPG	4

Photo: 1\_1\_10\_A.JPG  
 13.5m, Settled deposits, coarse, 40% cross-sectional area loss, Start

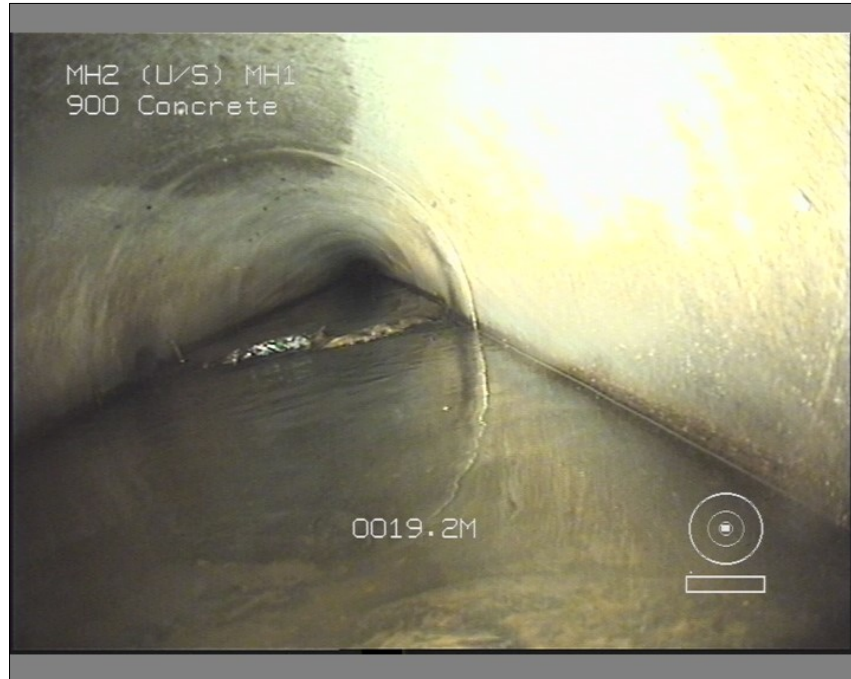
19.20	F02 DER	Settled deposits, coarse, 40% cross-sectional area loss, End		4
	19.20	S03 DER	Settled deposits, coarse, 50% cross-sectional area loss, Start	1_1_12_A.JPG	4

Photo: 1\_1\_12\_A.JPG  
 19.2m, Settled deposits, coarse, 50% cross-sectional area loss, Start

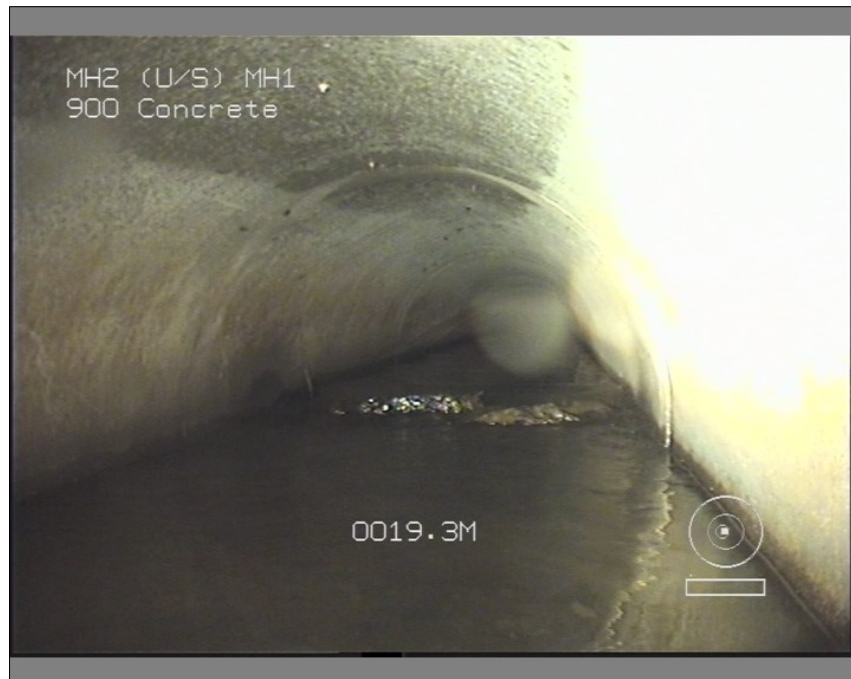
19.30	F03 DER	Settled deposits, coarse, 50% cross-sectional area loss, End		4
	19.30	SA	Survey abandoned Remarks: Due to amount of debris	1_1_14_A.JPG	0

Photo: 1\_1\_14\_A.JPG  
 19.3m, Survey abandoned

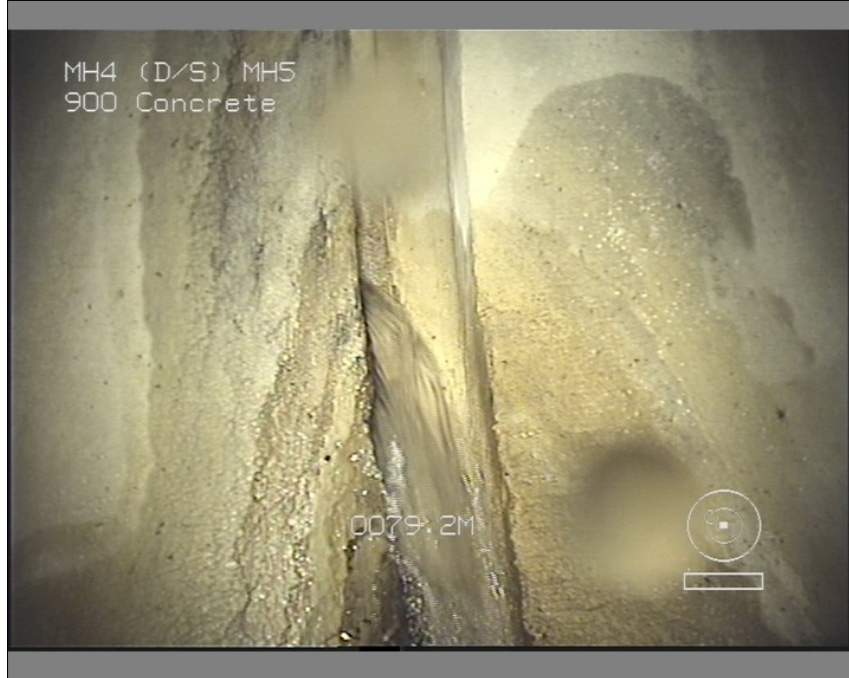
0.00	WL	Water level, 10% of the vertical dimension	0
		79.20	IGJ	Infiltration, gushing at joint, from 7 to 10 o'clock	0

Photo: 5\_5\_24\_A.JPG  
79.2m, Infiltration, gushing at joint, from 7 to 10 o'clock
